Fw 190D

Walk Around Number 10
squadron/signal publications

By E. Brown Ryle and Malcolm Laing

Focke-Wulf Fw 190D-9

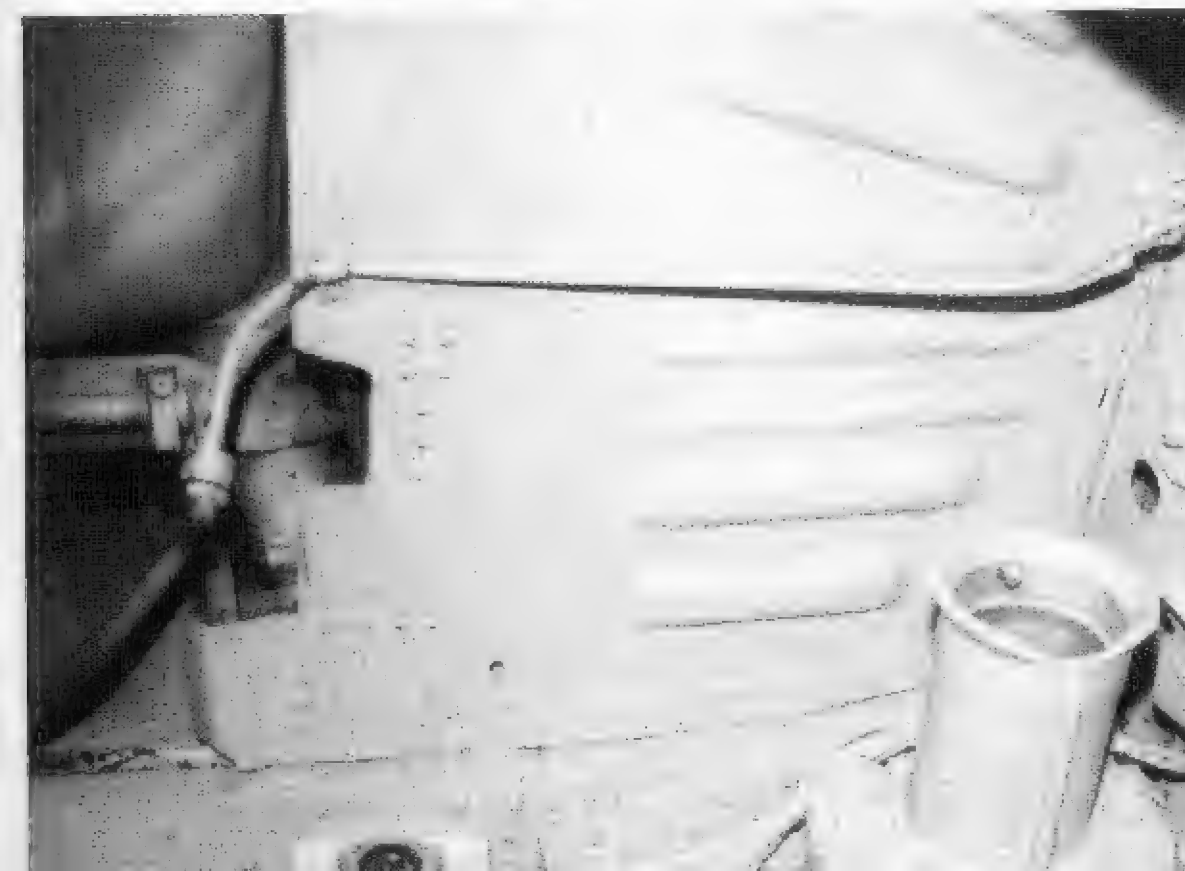
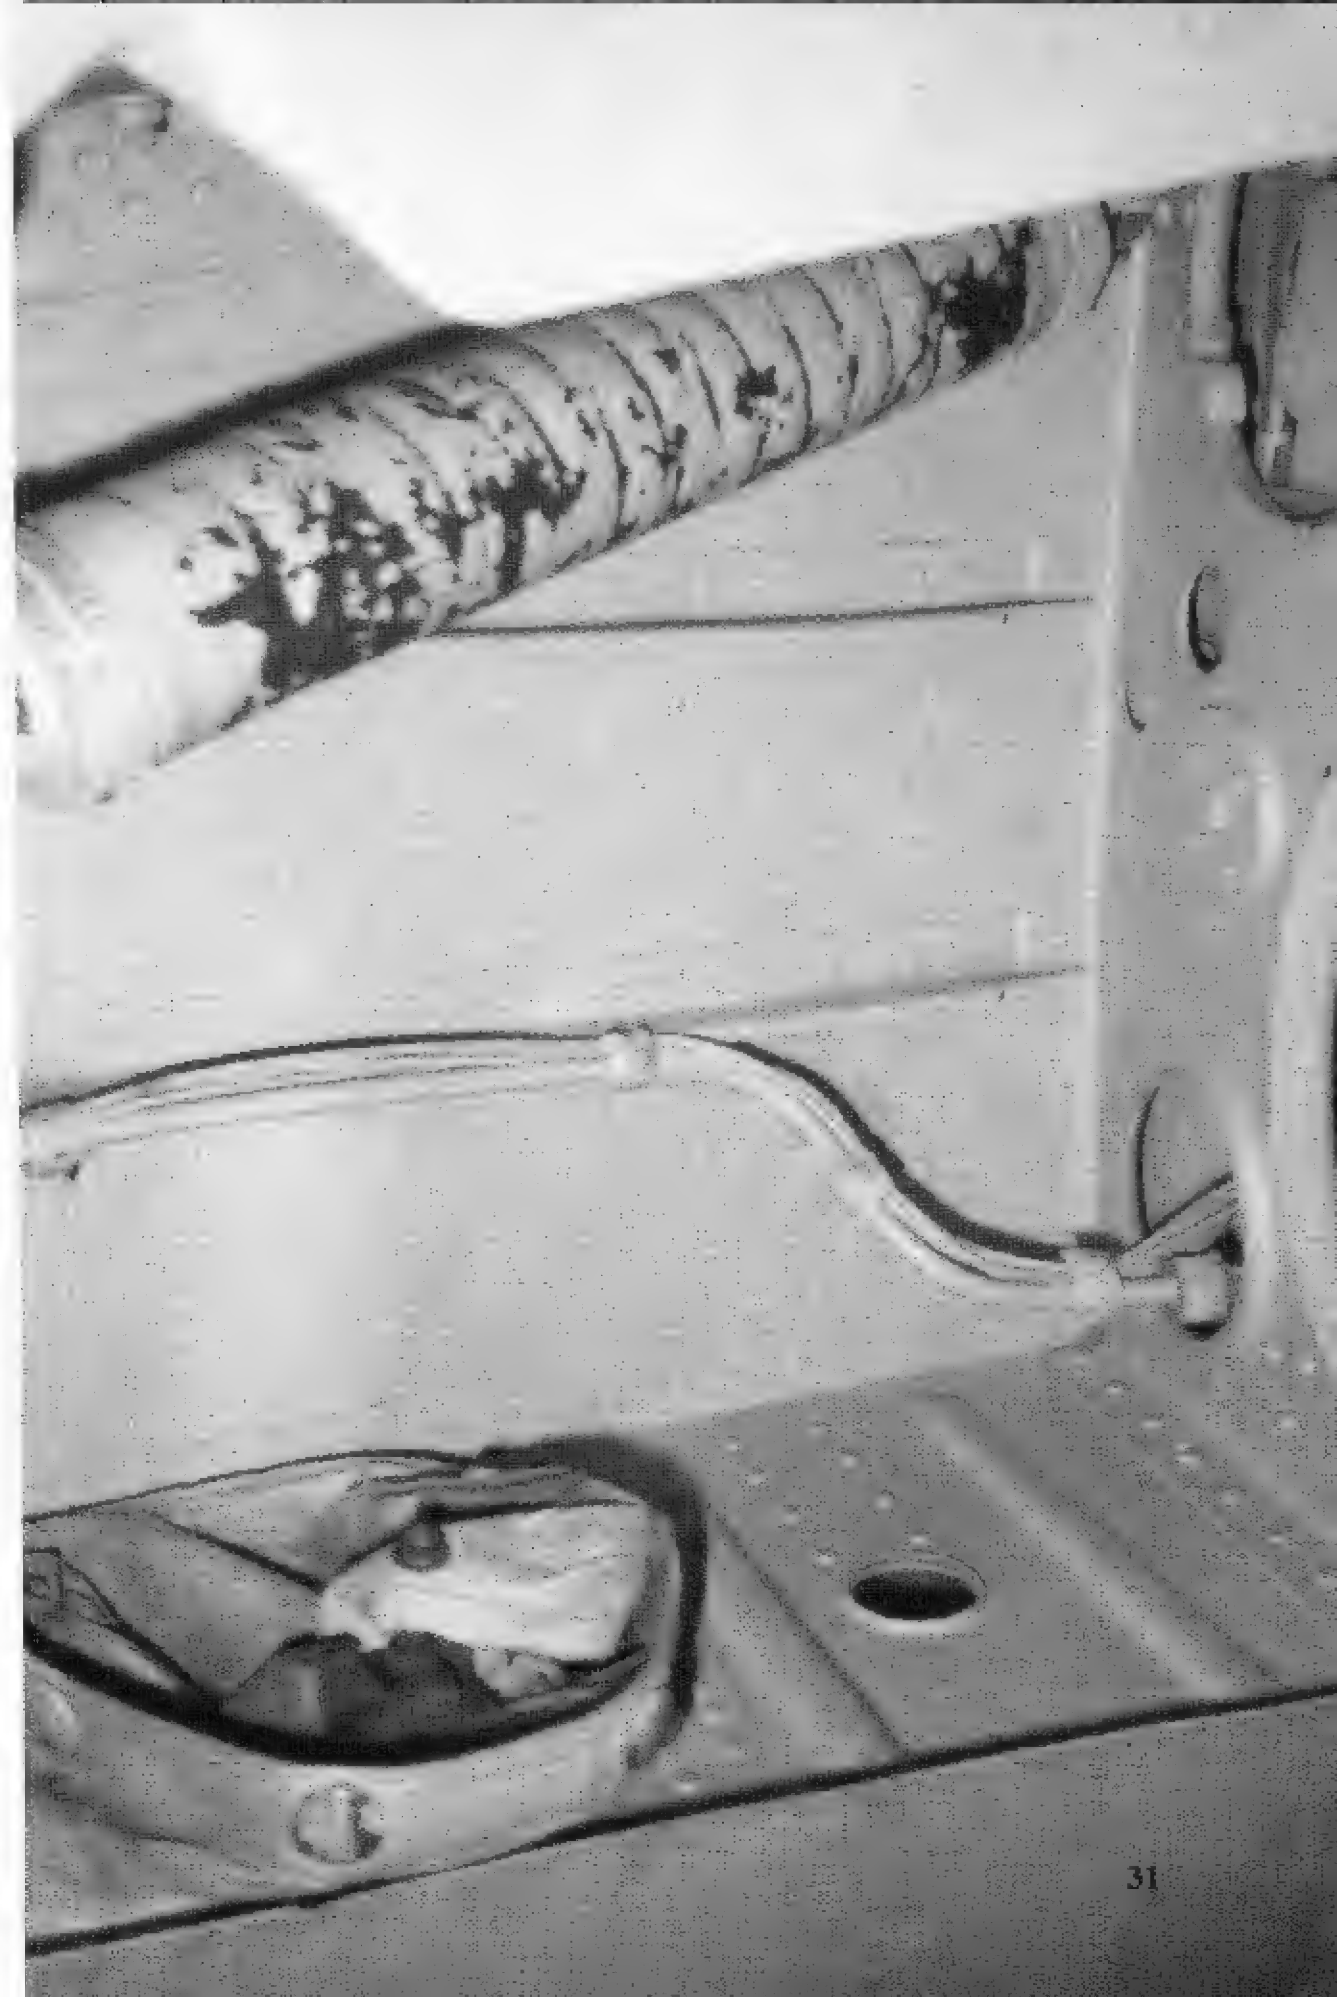
(Above and right) The forward wall of the port wheel well looking at the gun camera mount. When the pilot pressed the firing button for the wing root cannon the camera would start rolling. The gun camera, a BSK 16 16mm movie camera, was rarely installed. When the gun camera was installed, it was protected by a canvas cover. The over-sprayed remains of this cover are still installed. (Author: Ryle)

The port wheel well with the 20mm cannon mount in the back wall and the gear up-lock assembly to its right. The color of the wheel well is an RLM 76 Gray. A late war wheel well might be painted one of the following colors: RLM 02, 66, 76, 77 (primer Gray) or left unpainted in natural metal. (Author: Ryle)

At the top of the landing gear cover are two bolt holes usually covered with fabric and painted. This fabric has been removed from the port gear covers and the bolts are visible. This was a common occurrence on Fw 190 landing gear. (Author: Ryle)

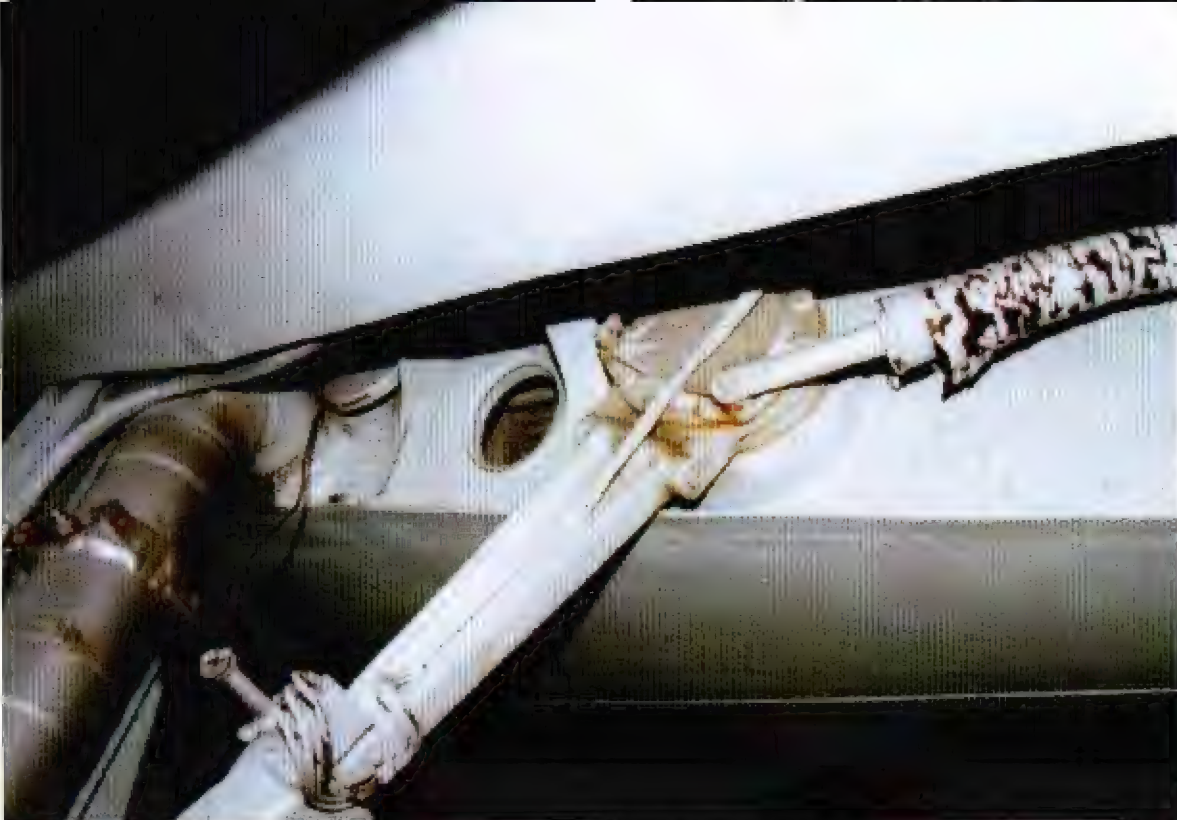
(Above) The upper radius rod of the starboard main gear and its attachment to the electric landing gear motor in the wing. Wiring for the microswitch on the bottom of the upper radius rod is attached. (Author: Ryle)

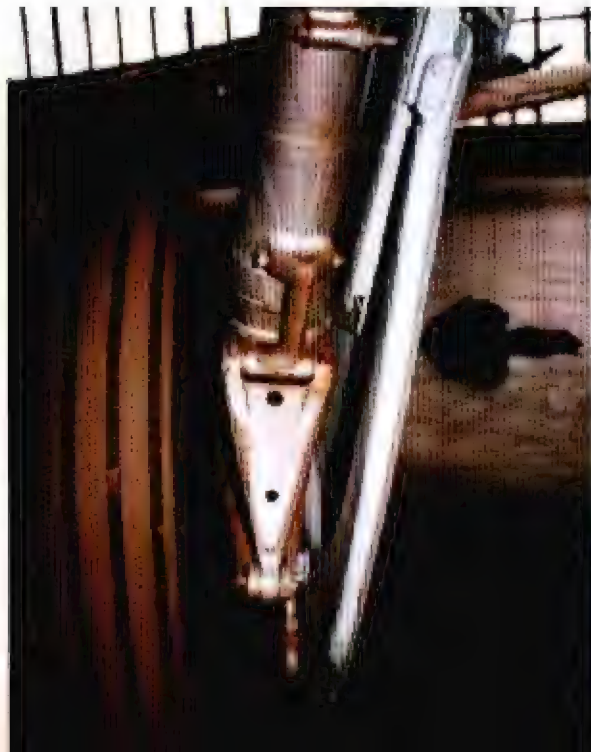
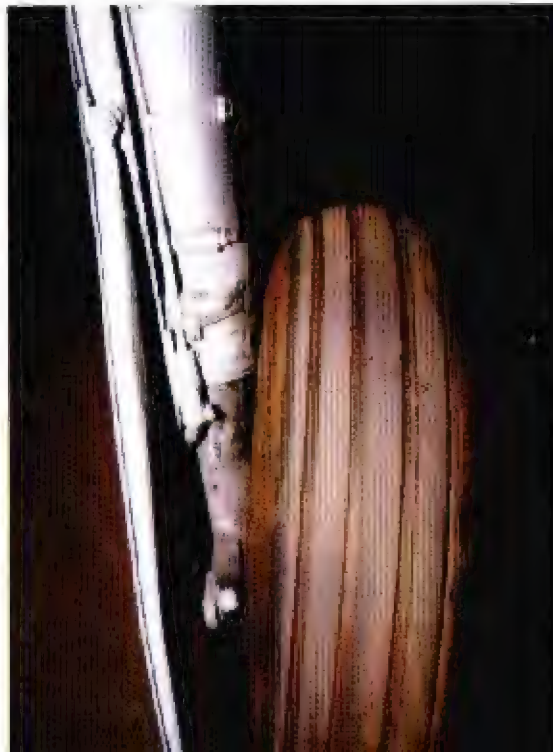
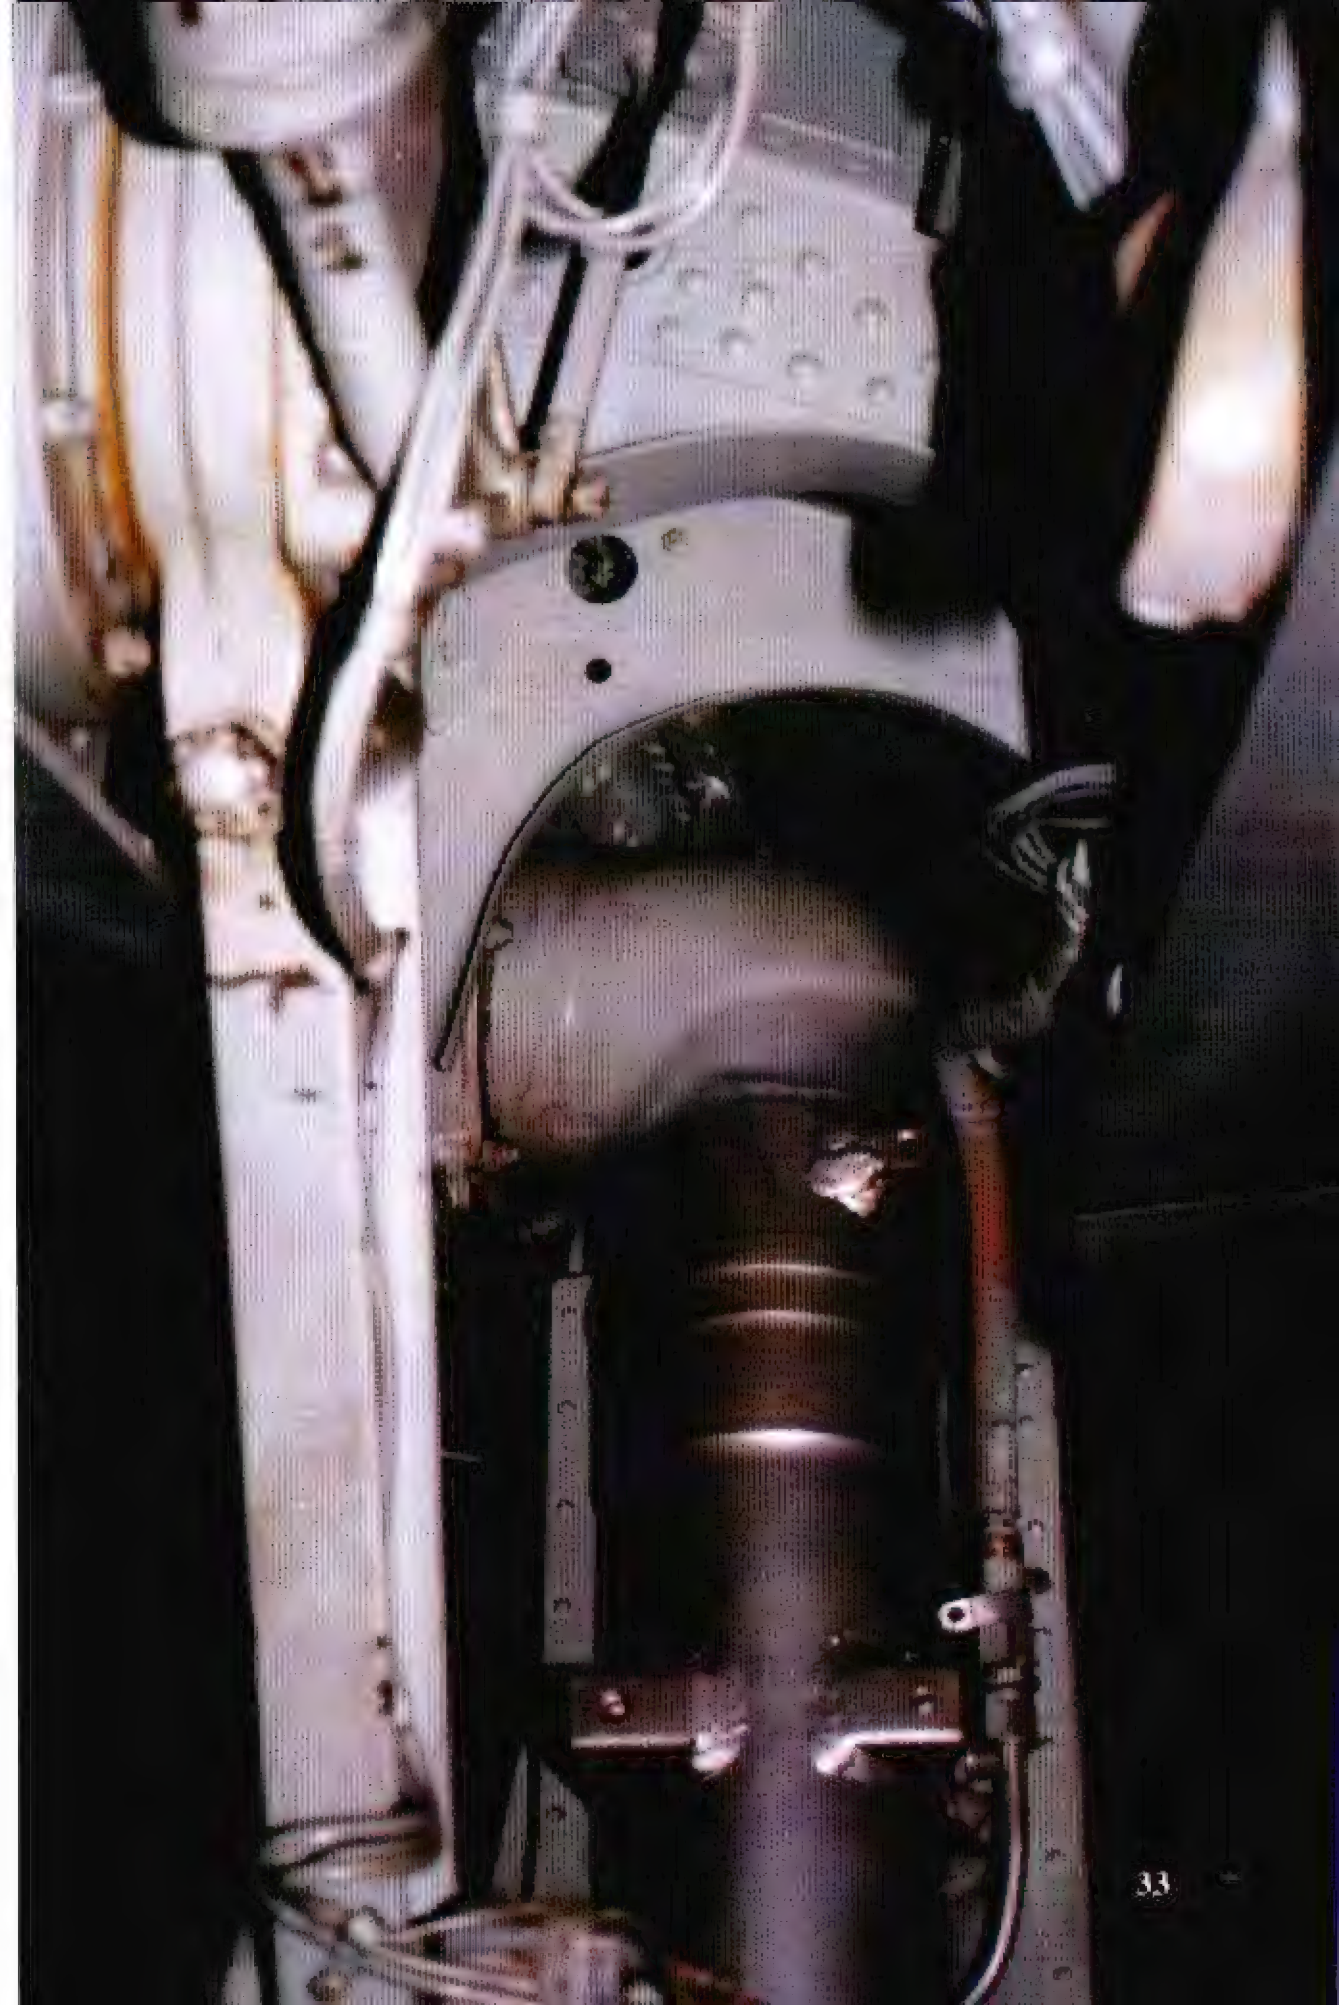
(Bottom Left) The rear of the starboard landing gear leg and linkage. Hanging from the bottom is the disconnected brake line. (Bottom Right) The lower front of the starboard landing gear. The brake line is attached to strut via small hose clamps — a common attachment method for brake and hydraulic lines. The piece extending outward from the bottom of the strut is the lower faring attachment outrigger. (Author: Ryle)

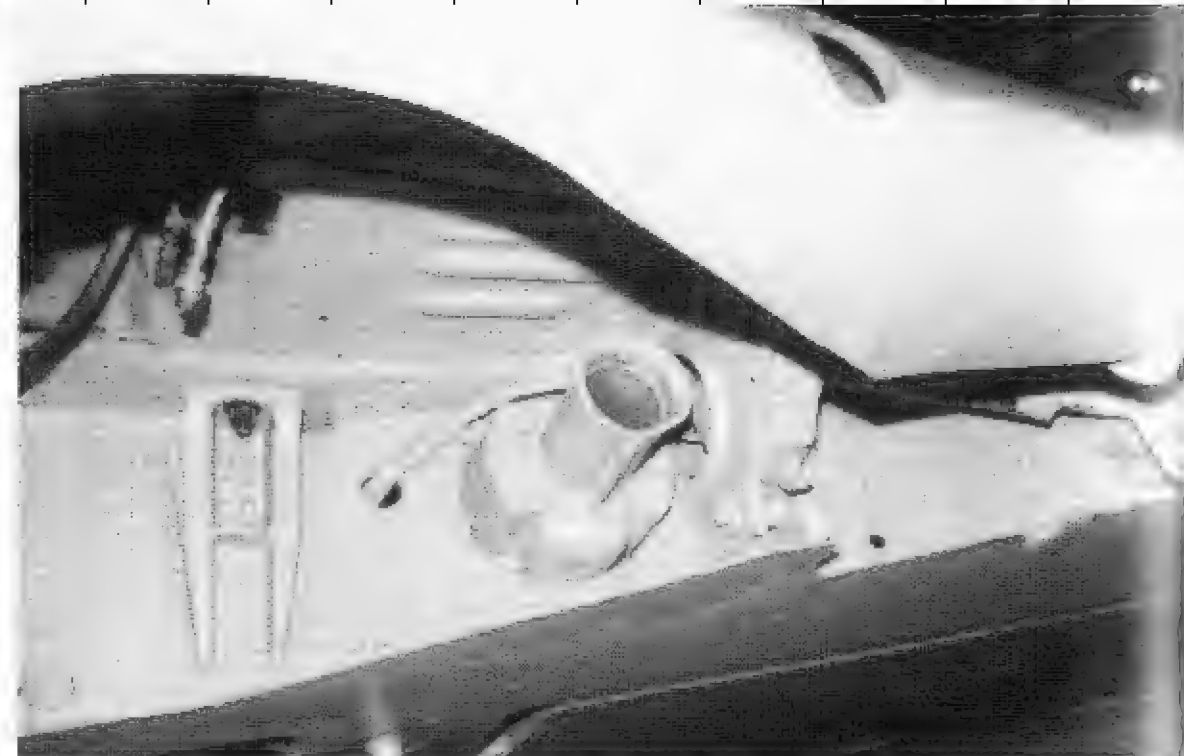
(Above) This photo shows the correct position of the electric gear drive, linkages and the strut.

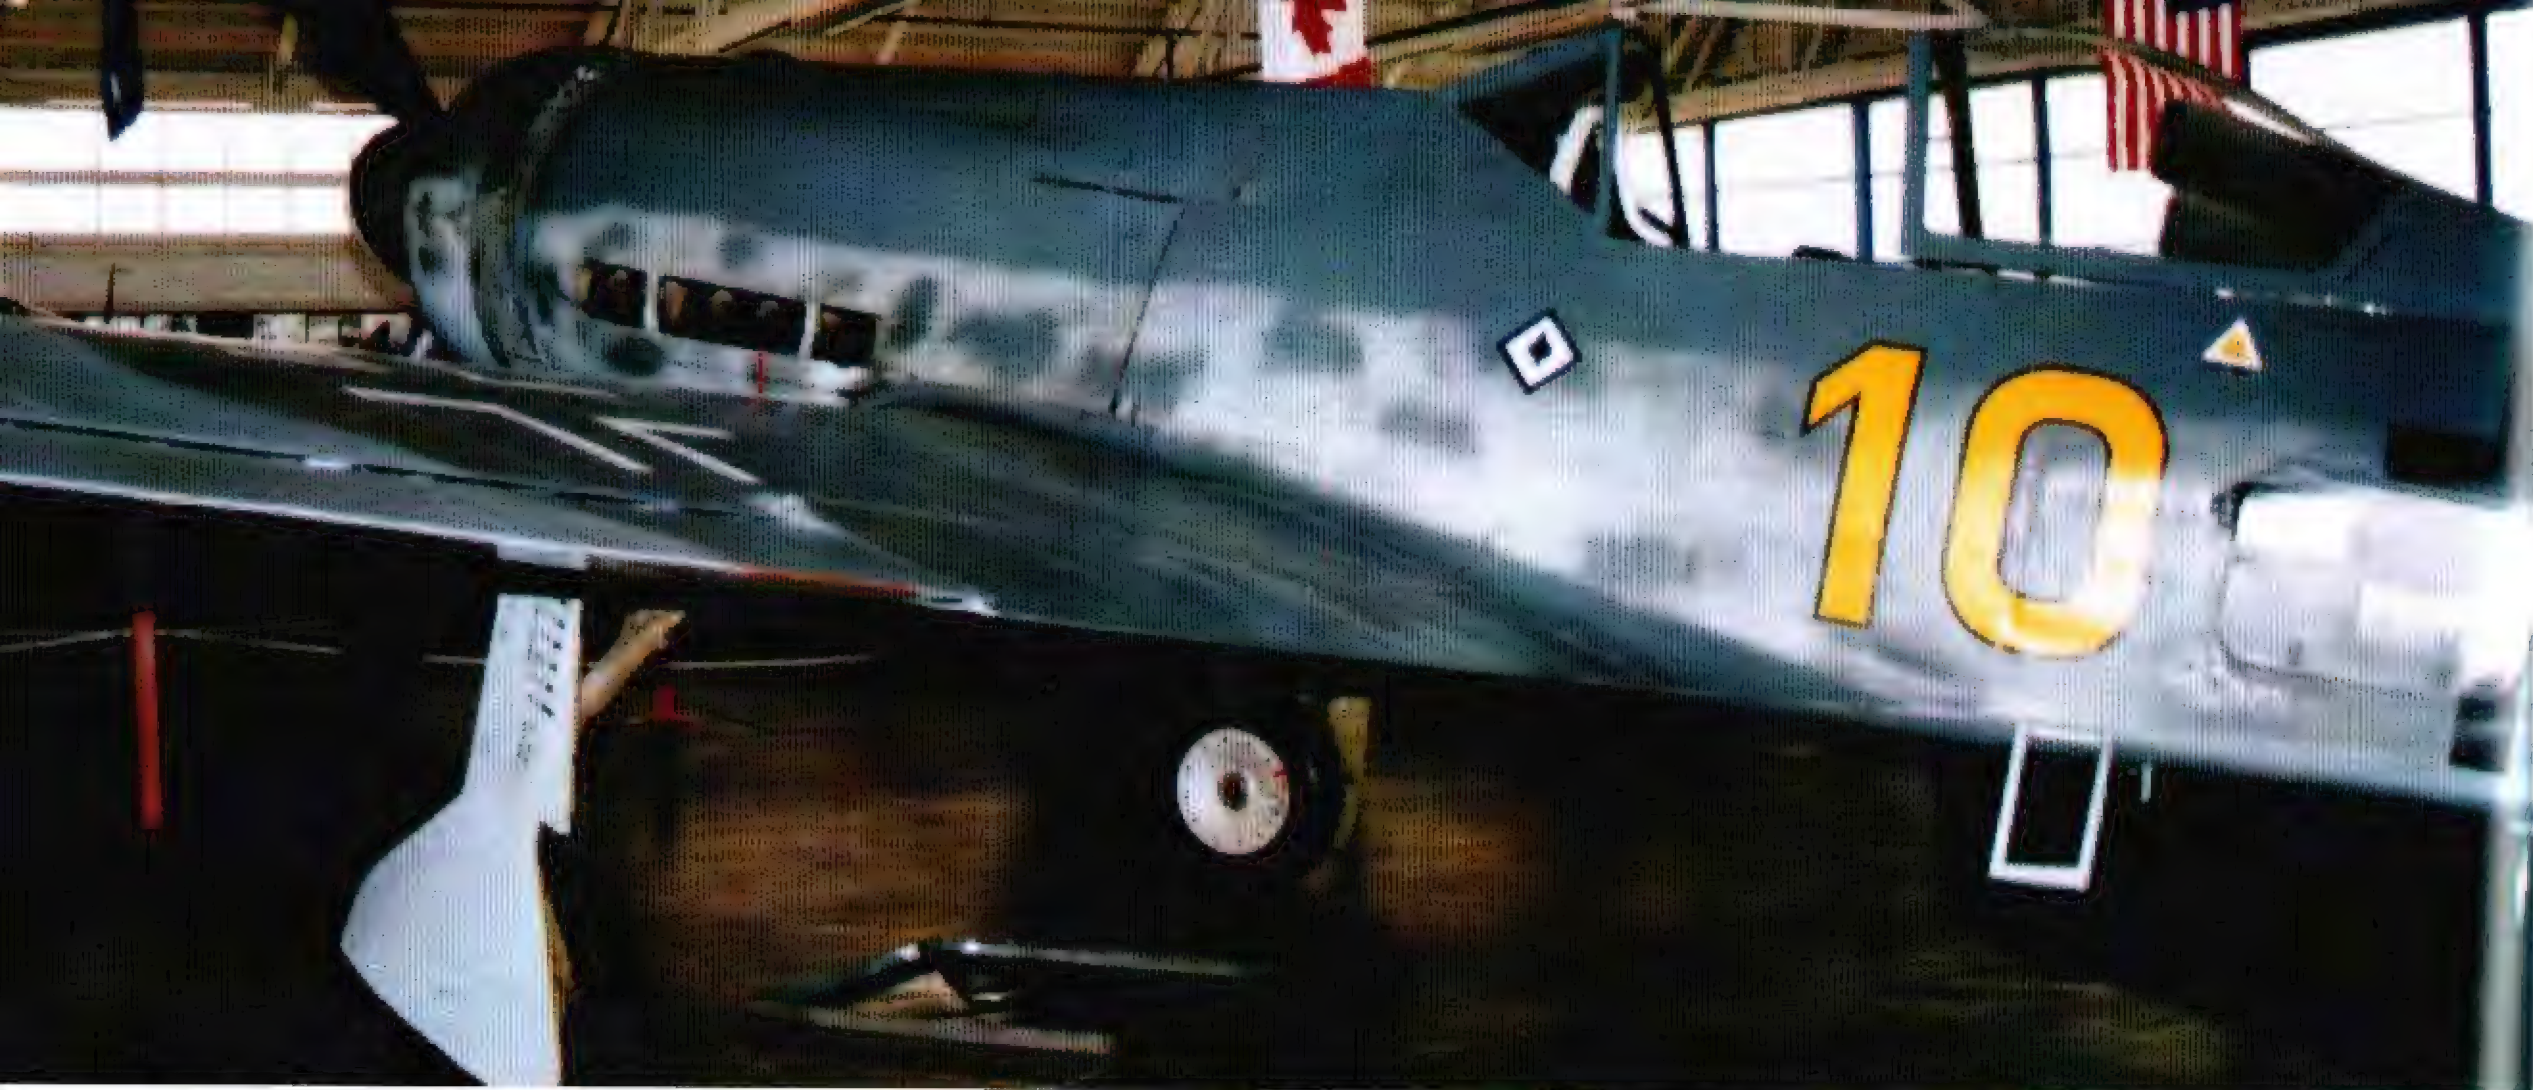
(Above) The port side of the Champlin Fighter Aces Museum's Fw 190D-13. It is believed that this was the 17th Fw 190D-13 manufactured. Built by Roland in March of 1945, the fuselage for the Fw 190D-13 was rebuilt from an Fw 190A-8 airframe (1740) which had been produced at the Focke-Wulf plant at Cottbus in May of 1944. This rebuilding of usable airframes was a common practice with Fw 190 production. (Author: Ryle)

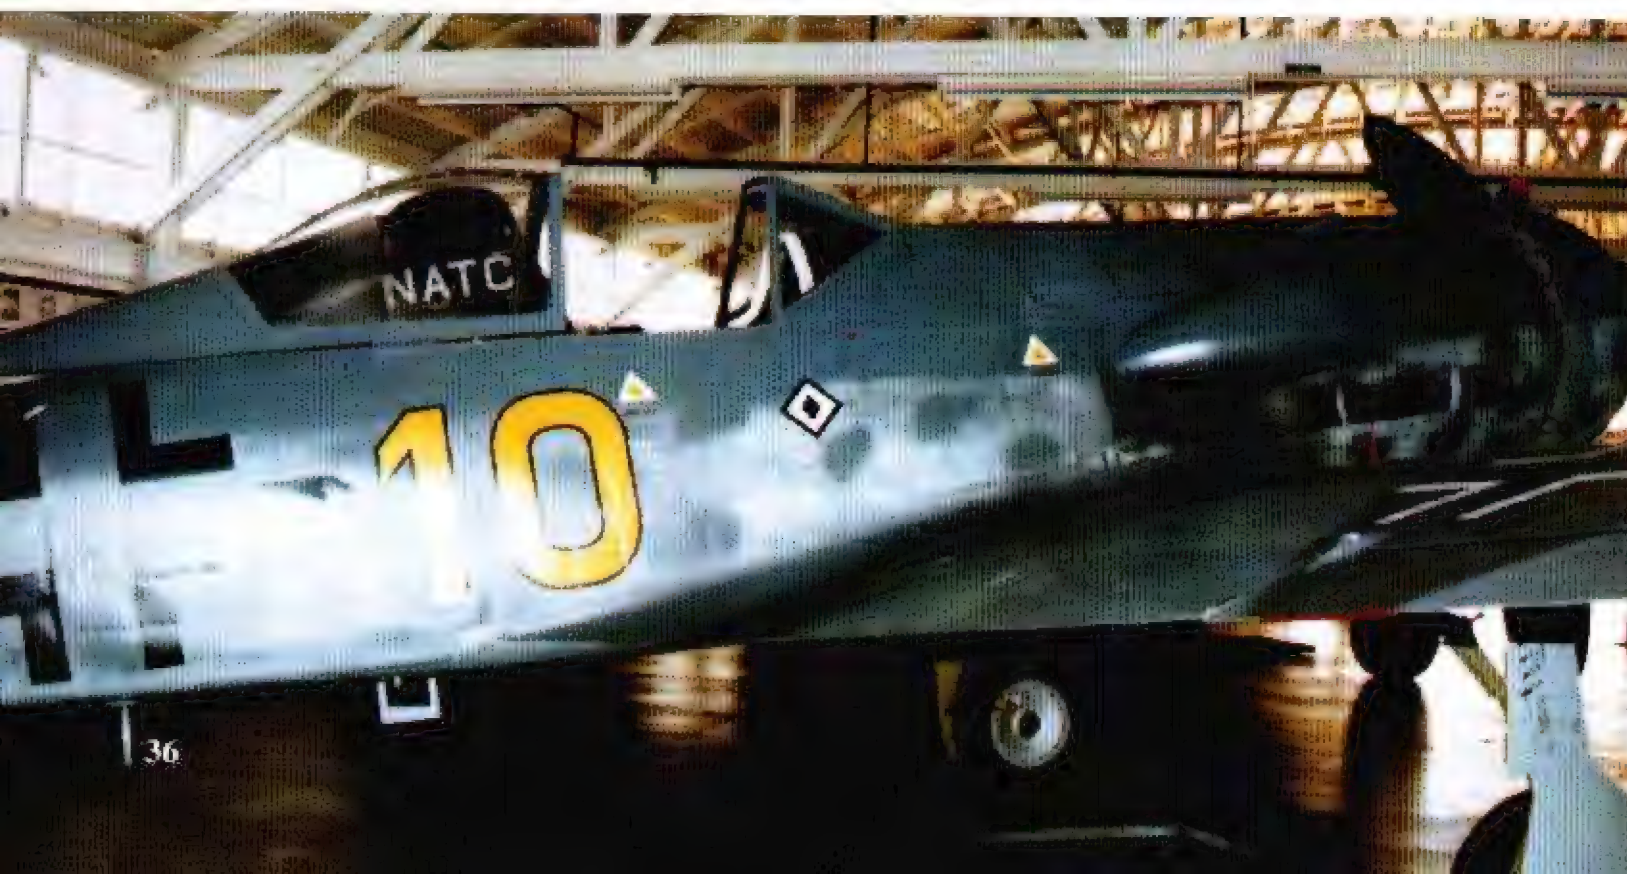
(Left) The supercharger intake on the starboard side of the engine compartment is a feature specific to the Fw 190D-13, however the D-13 had a much larger and differently shaped supercharger intake than the D-9. (Author: Ryle)

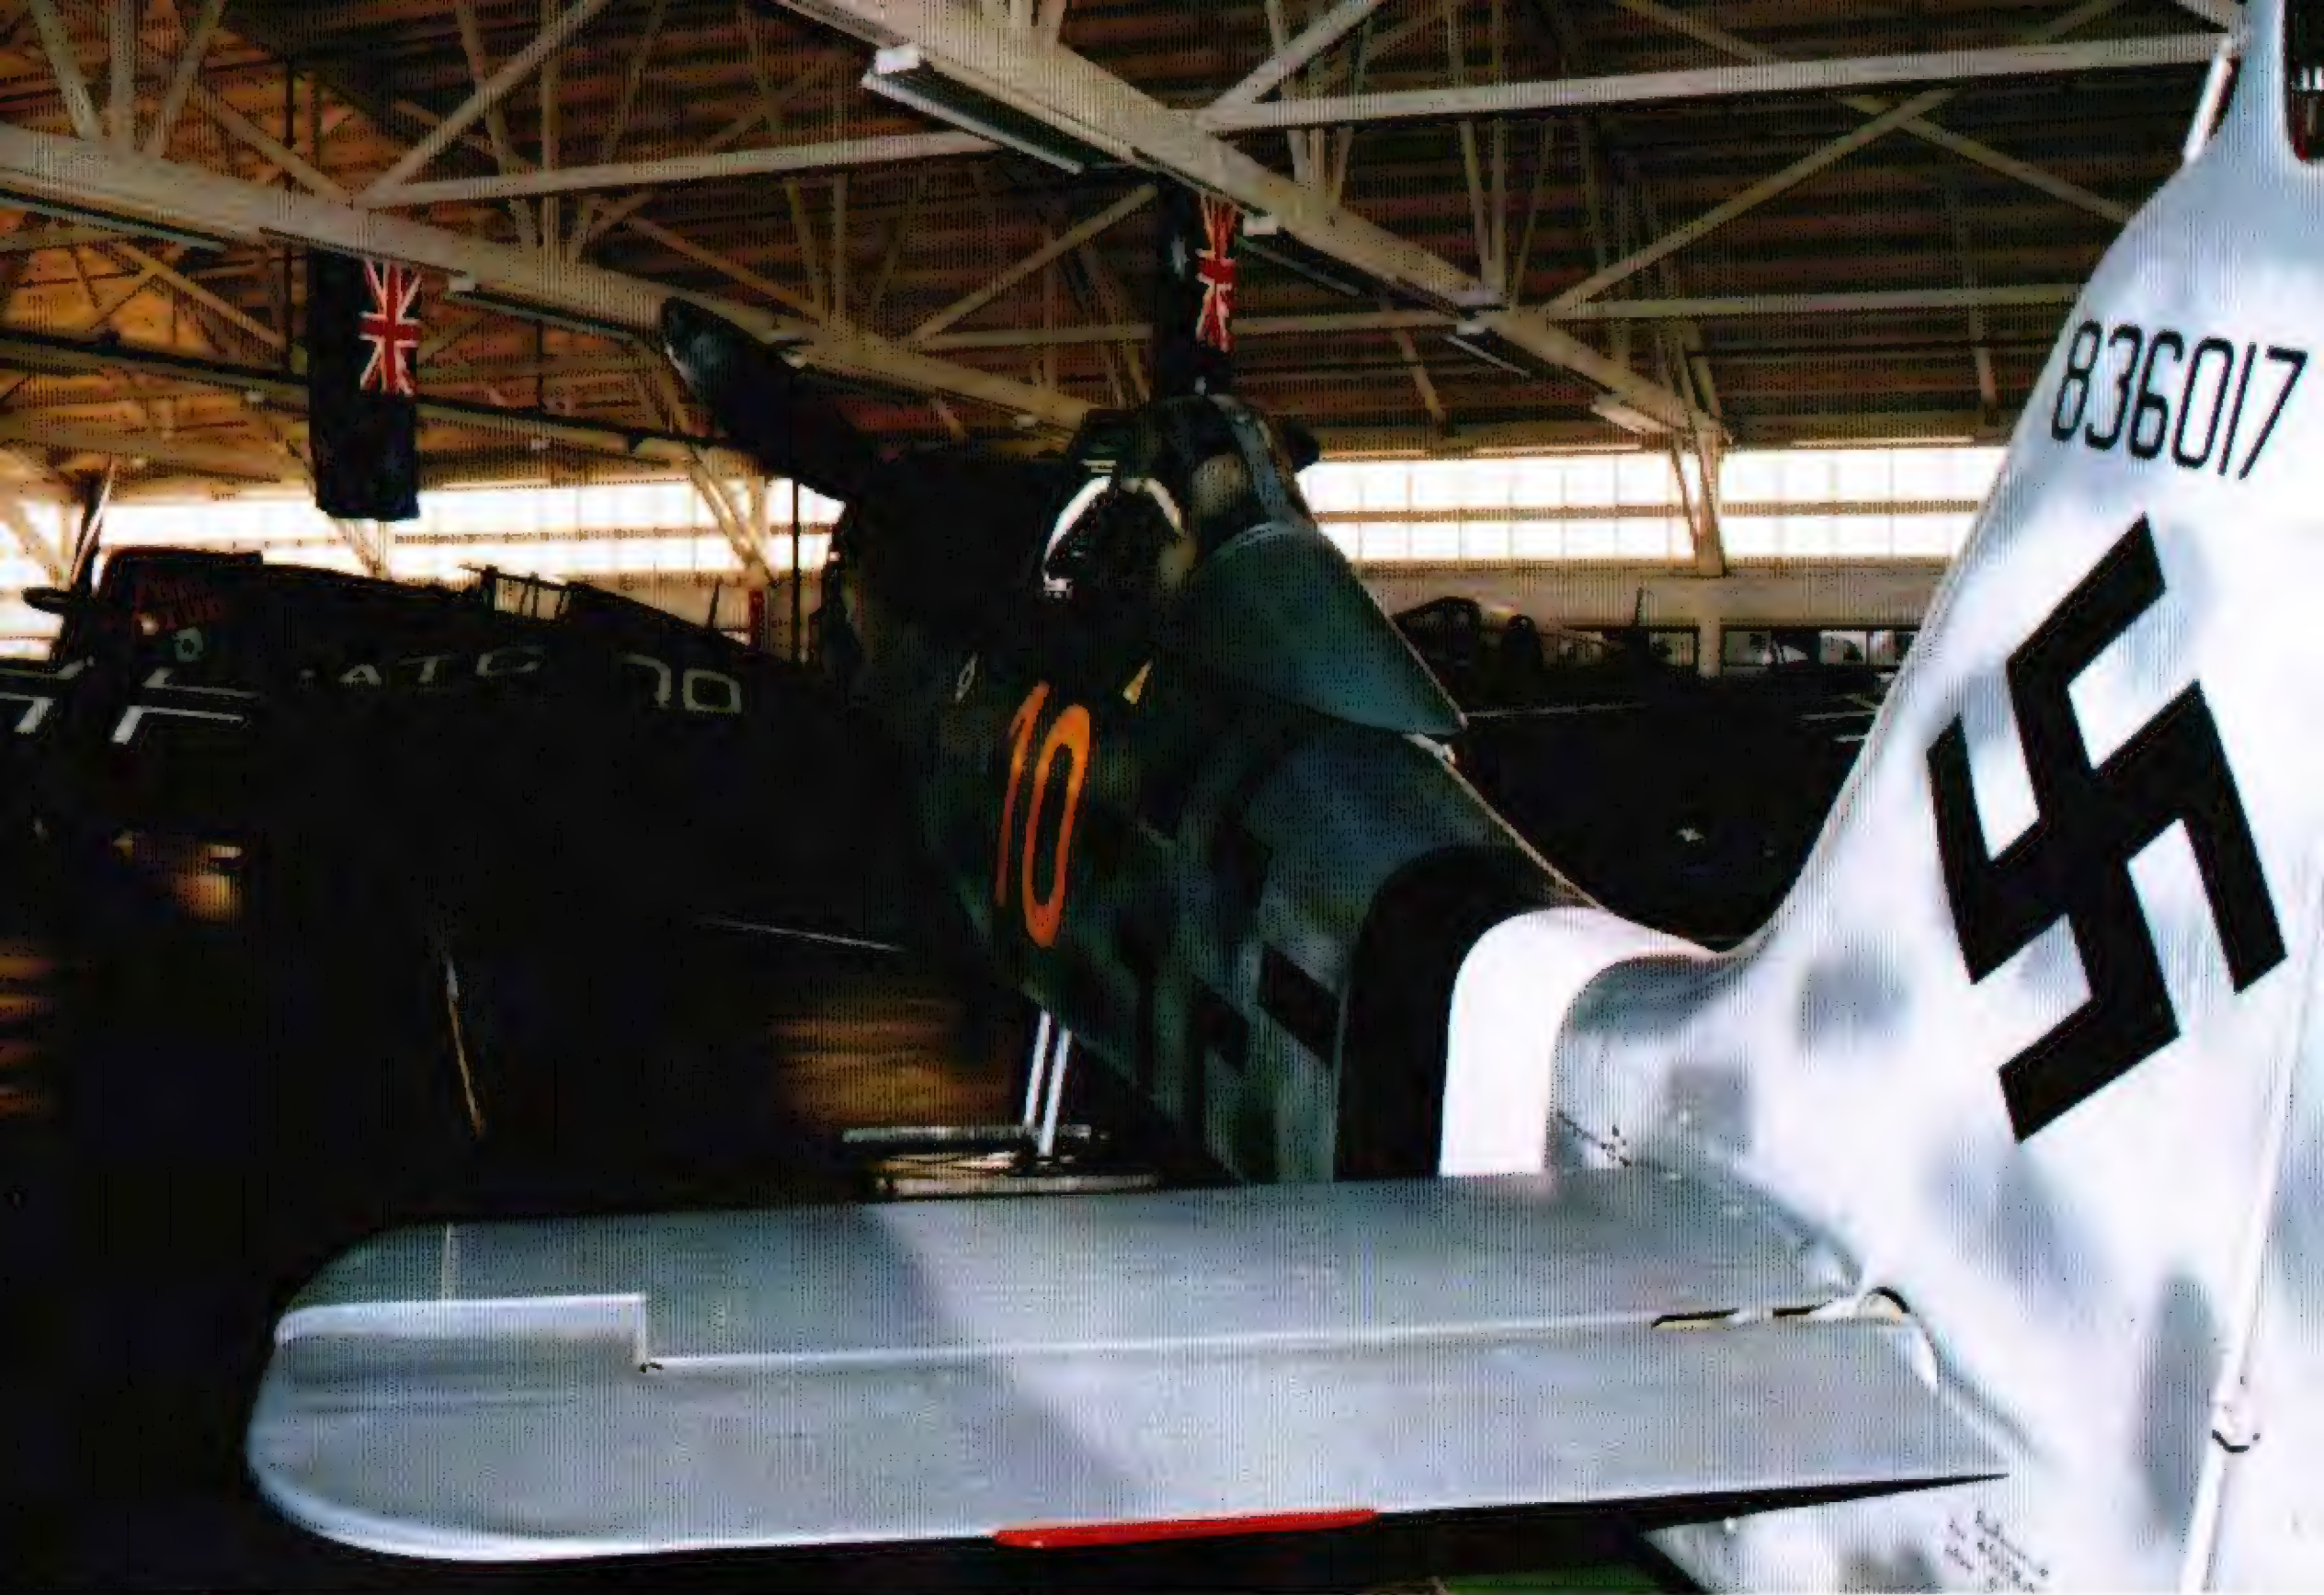
The trailing edge of the horizontal stabilizer along with its connection to the elevator. The aircraft's Work Number (836017) is at the top of the vertical fin. The placement of the Work Number in this location was a standard practice throughout the war. (Author: Ryle)

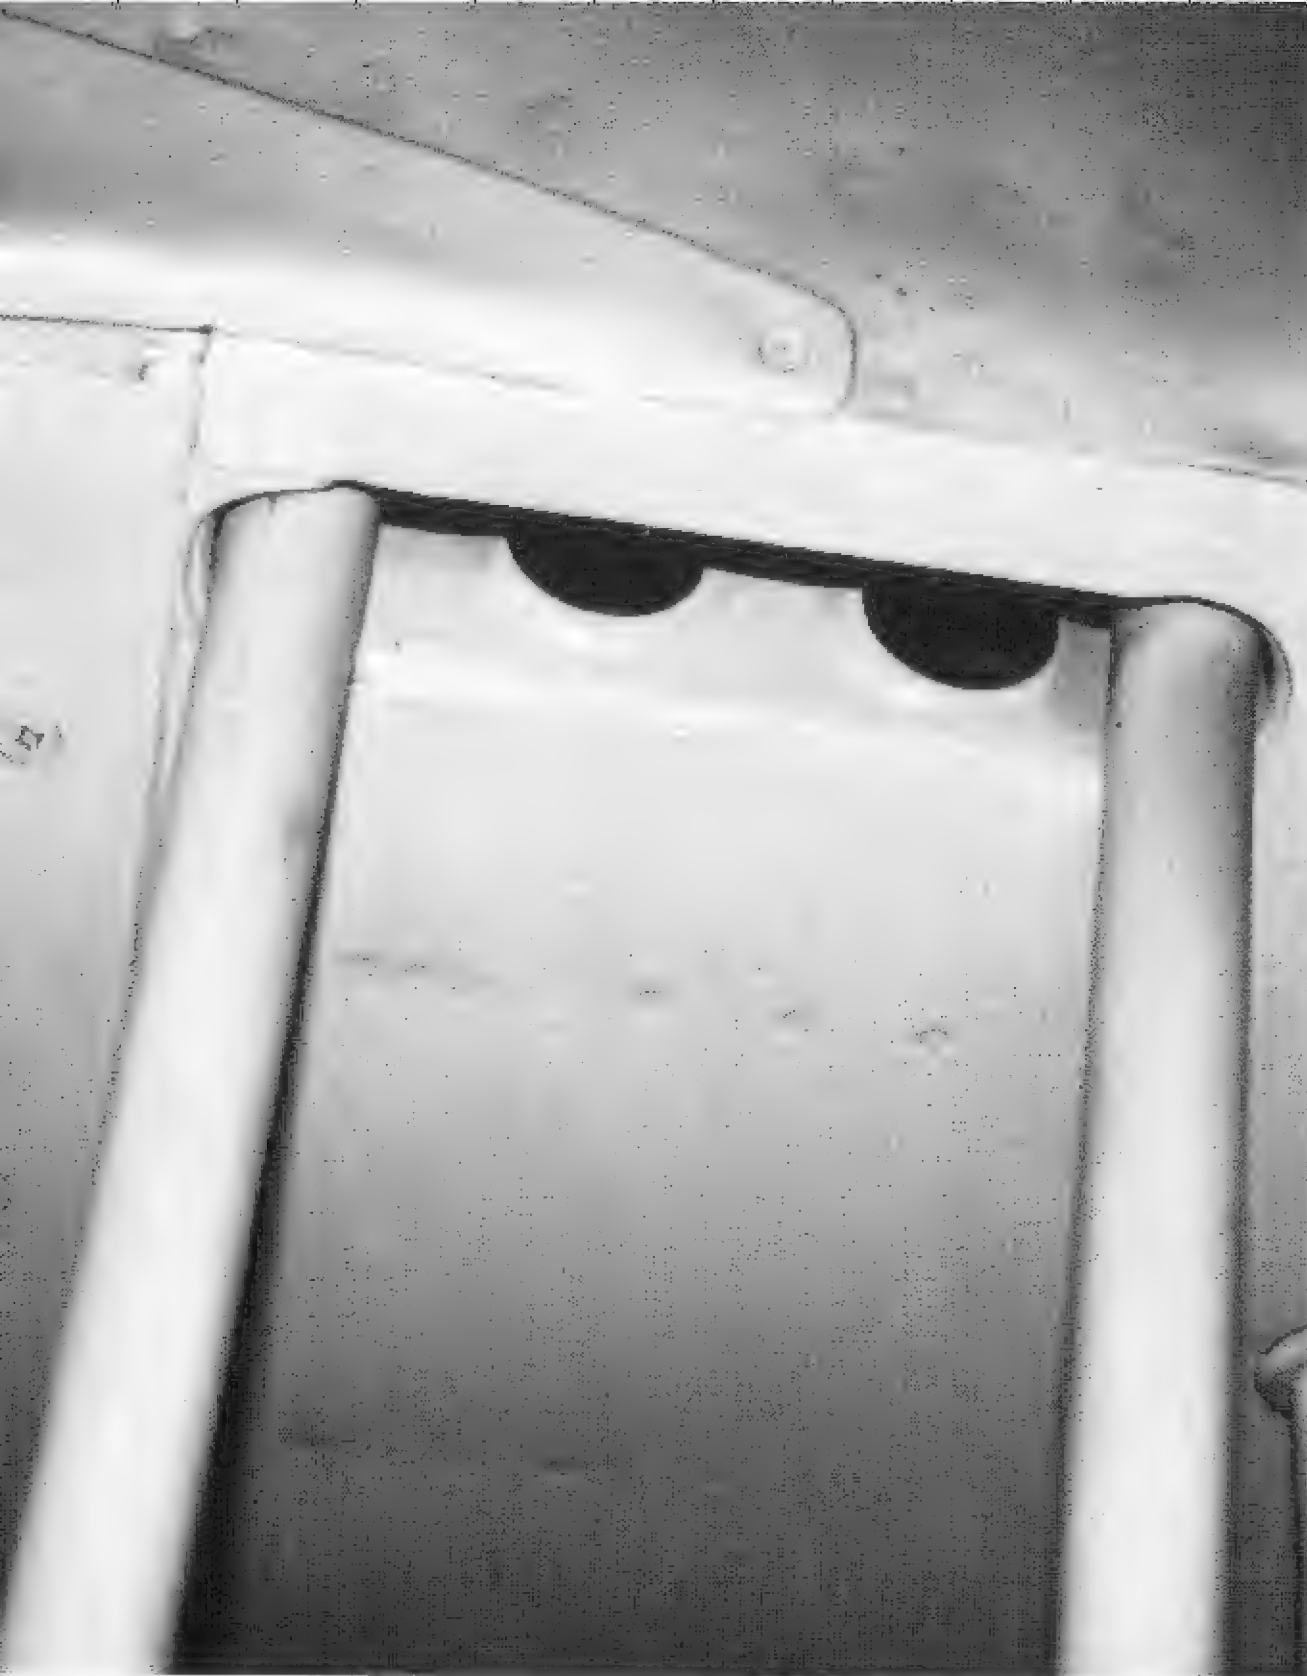
The pilot's extendible step on the port side of the fuselage. The two holes in the step's retraction trough are designed to both stiffen and lighten the step assembly. The small tube just to the right of the step is the auxiliary fuel tank overflow. In use, this tube may have been shorter than the one seen here. (Author: Ryle)

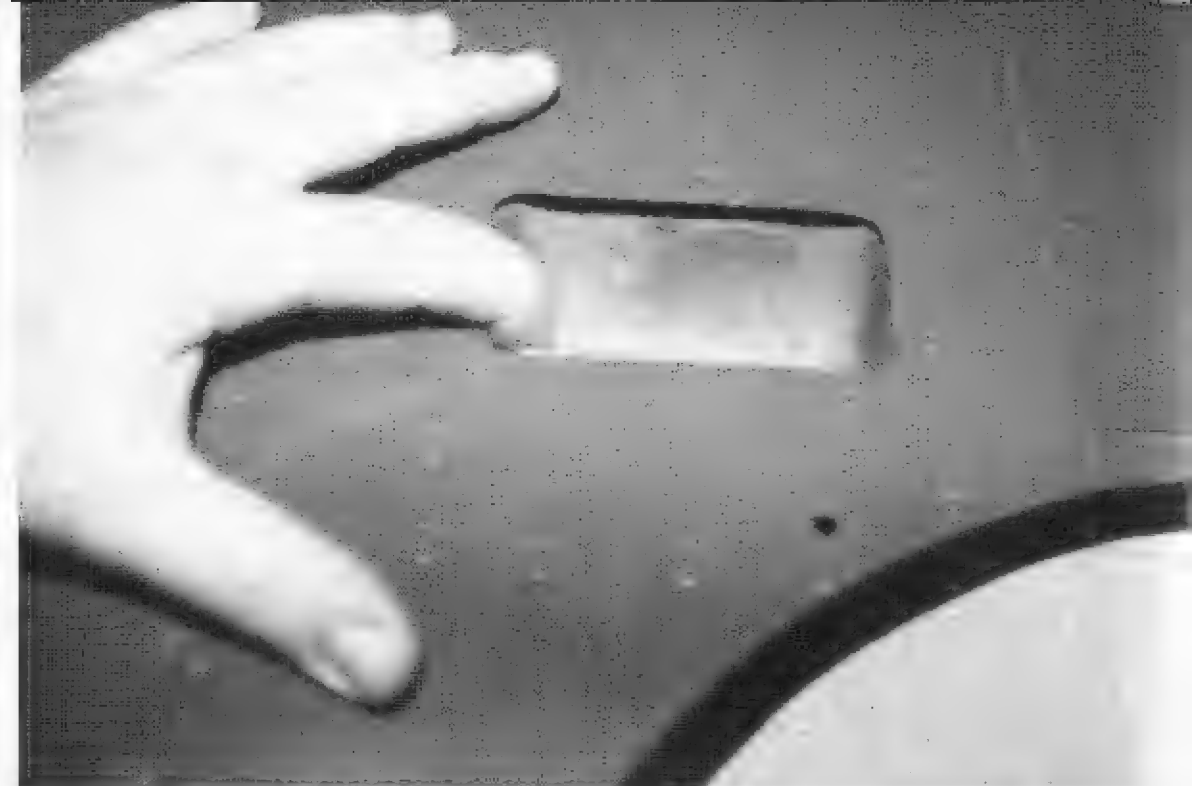
The pilot's hand grip on the port side of the fuselage is just above and forward of the Black outlined 'Yellow O'. The small button on the top of the 'Yellow D' is the button to release the droppable step. (Author: Ryle)

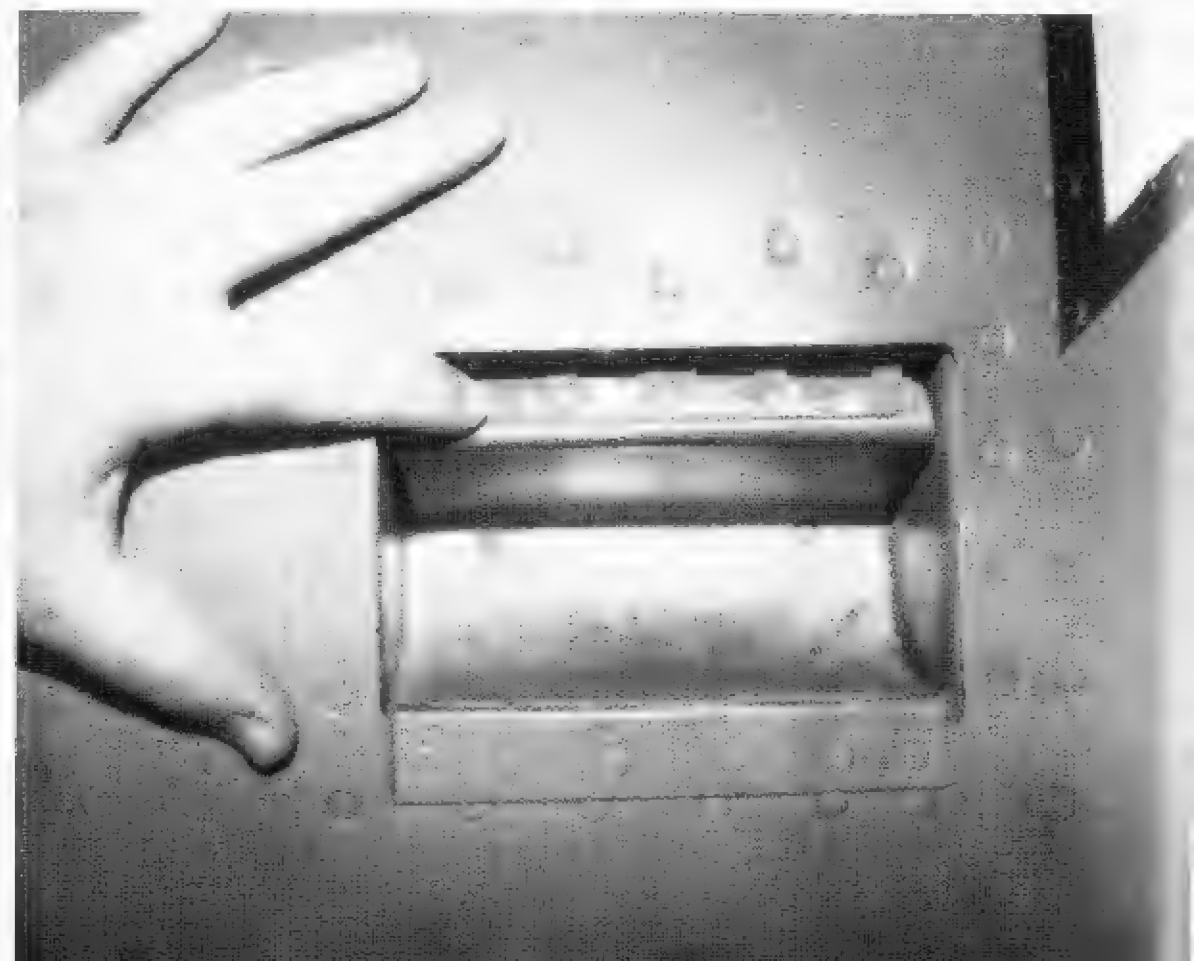
The pilot's foot step is located on the left side of the fuselage mid-way between the retractable foot step and the cockpit. The pilot would place his left foot in the step to assist his climb into the cockpit. (Author: Ryle)
